Conduit Inner Surface Inspection and Repairing Works

Sewer Pipeline Inner Surface Inspection

Sewer Works at Tokyo

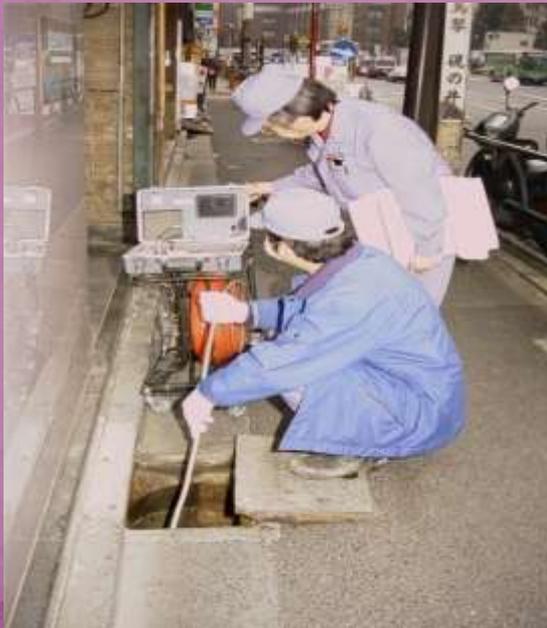
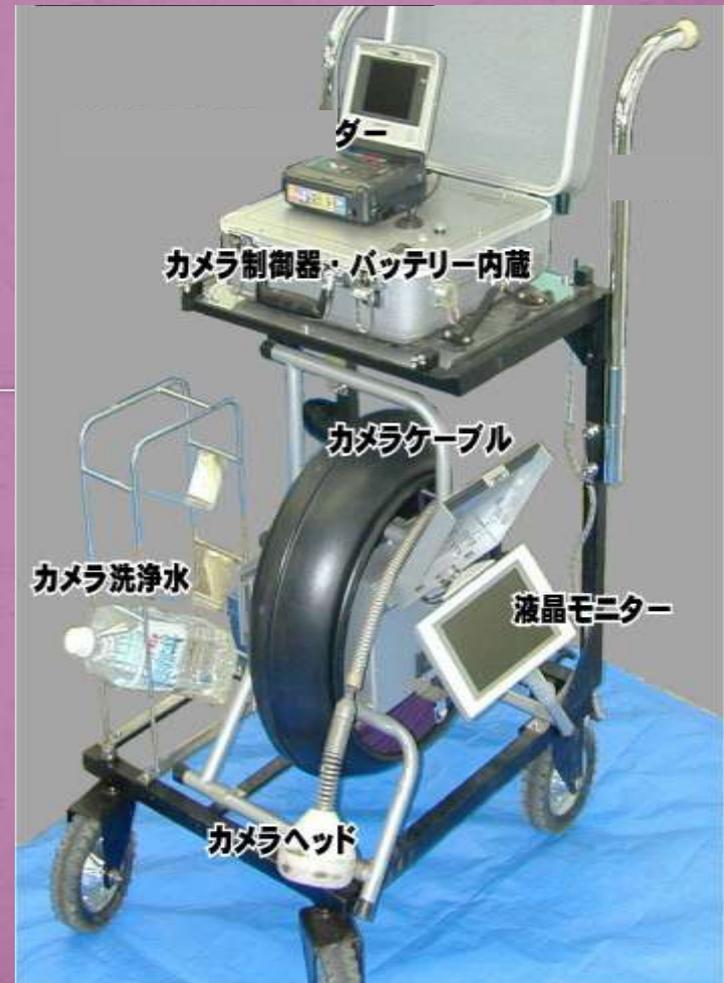
House Connection Inspection (with potable video camera)

Inspection of pipe with a diameter of 150mm-200mm through video camera inserted from house inlet to see any damage and deterioration of pipe.

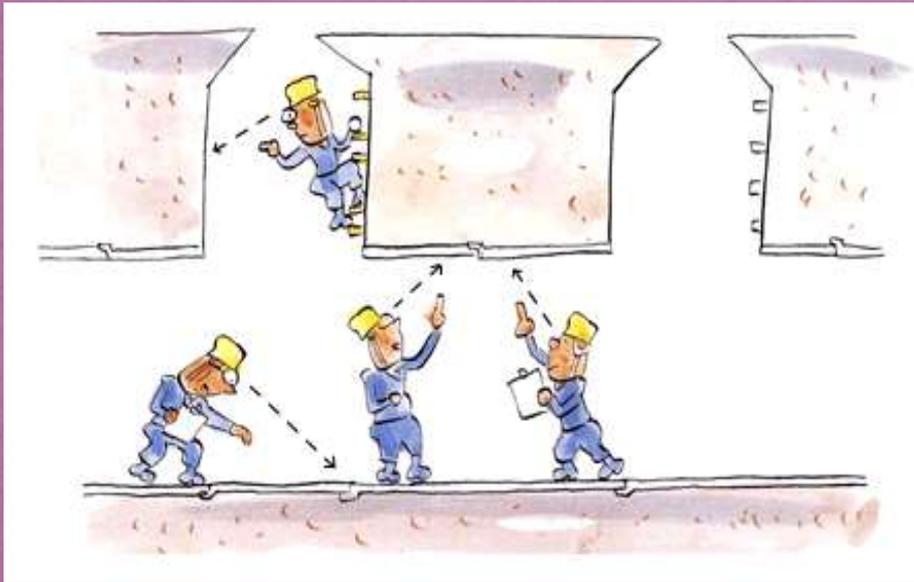
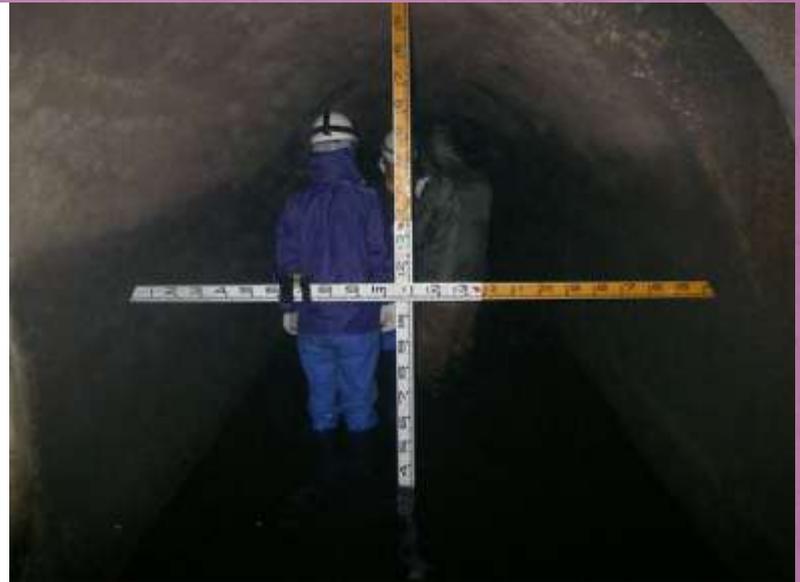
Main Pipe Inspection

Inspection of main pipe with a diameter of 800mm or larger by human eyes to see any defect in manhole wall joint, damage on pipe, disconnection of pipes, piling of sludge, etc.

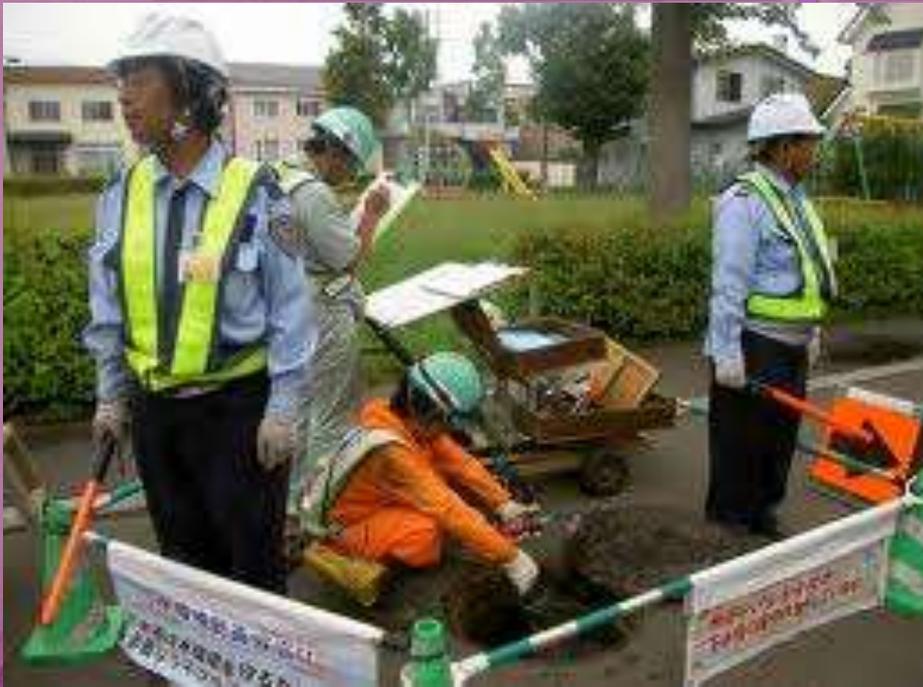
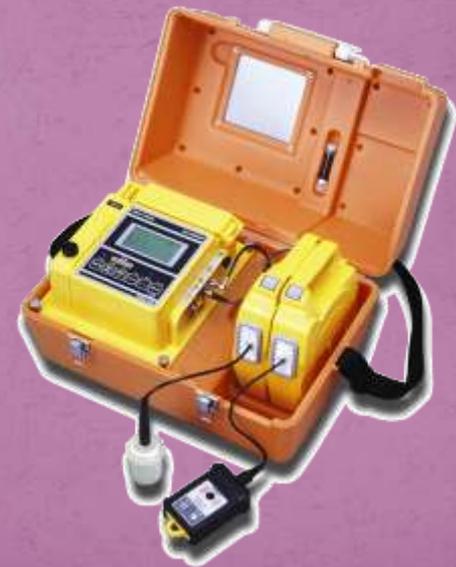
Gas detector

(1) Measurement of gas concentration

- Oxygen (more than 18%)
- Hydrogen sulfide (less than 10ppm)
- No flammable gas, no carbon monoxide

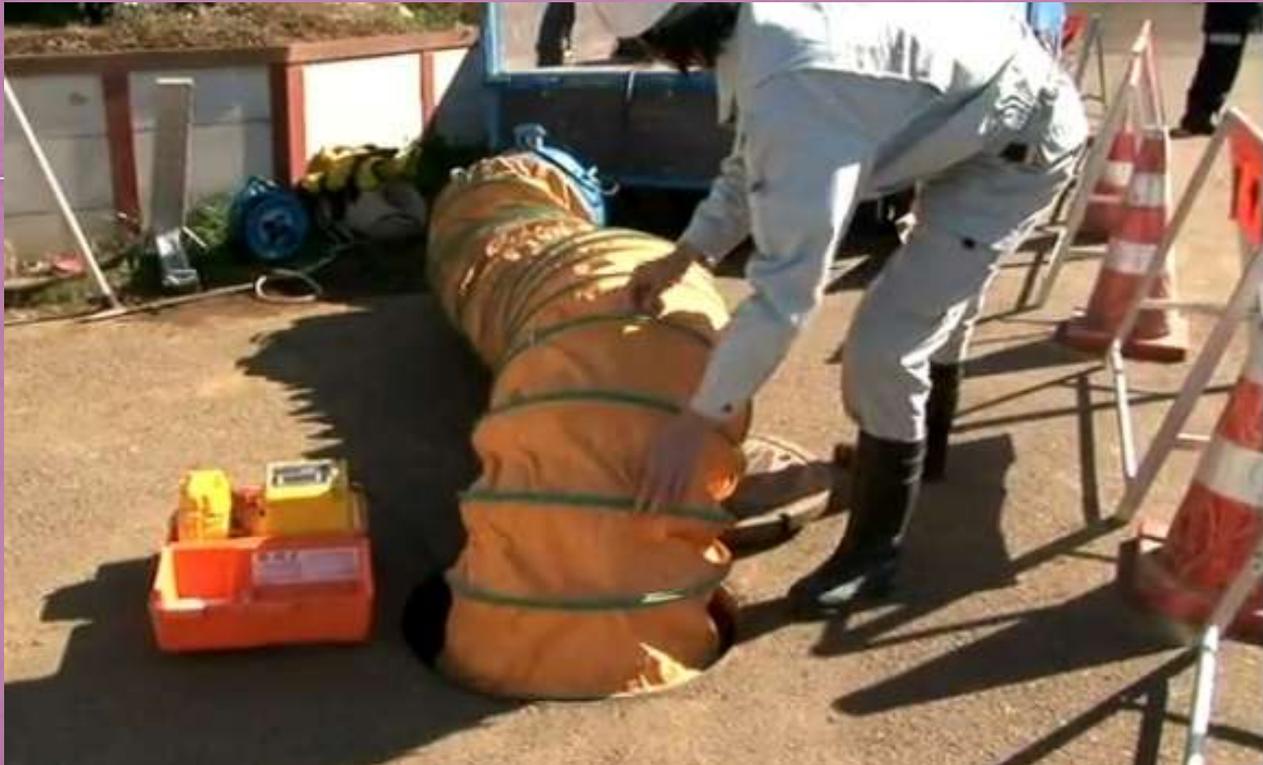
(2) Forced ventilation by air blower

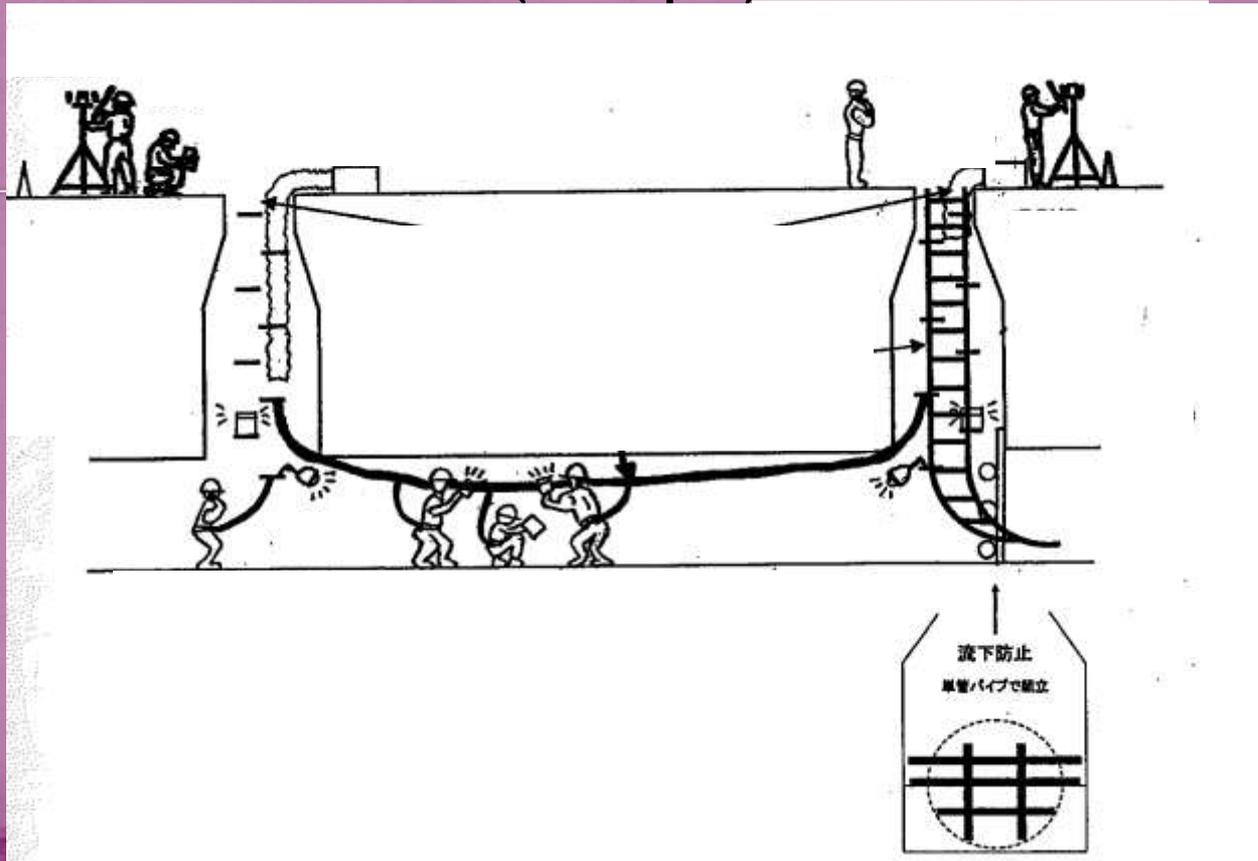
Visual inspection of pipe with a diameter of 800mm or larger

(3) Prevention of human loss (example)

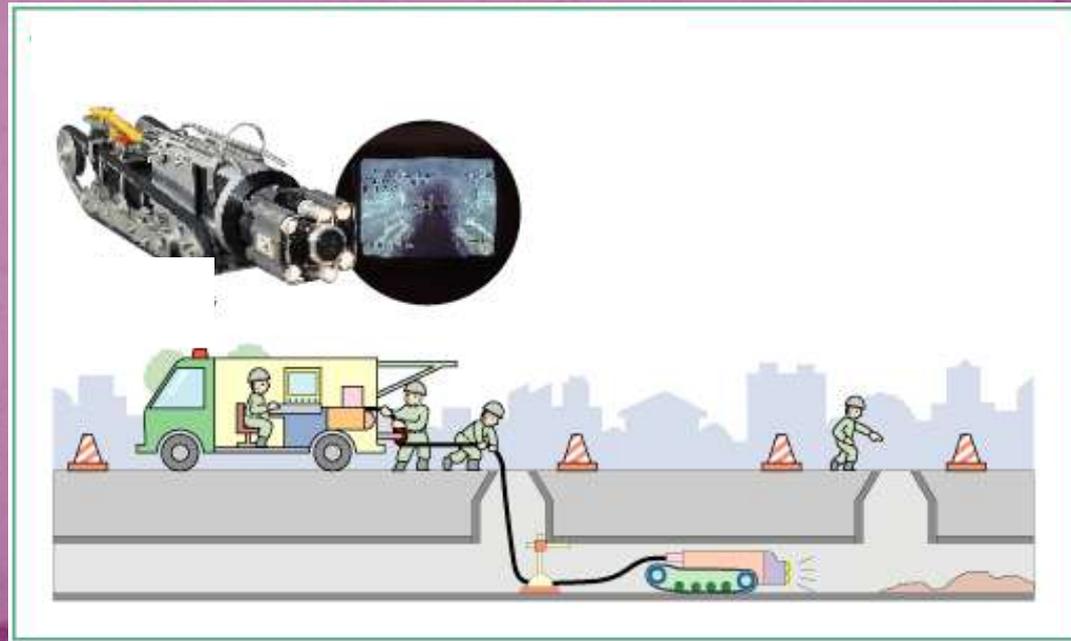
Inspection through video camera inserted and moved from upper to down stream at a steady pace to see any damage or deterioration of pipe.

- (1) Self-propelled type (as shown below)
- (2) Traction type (pulled by winch)

Self-propelled type is popular, but traction type is also used to overcome mortar-like obstacles.

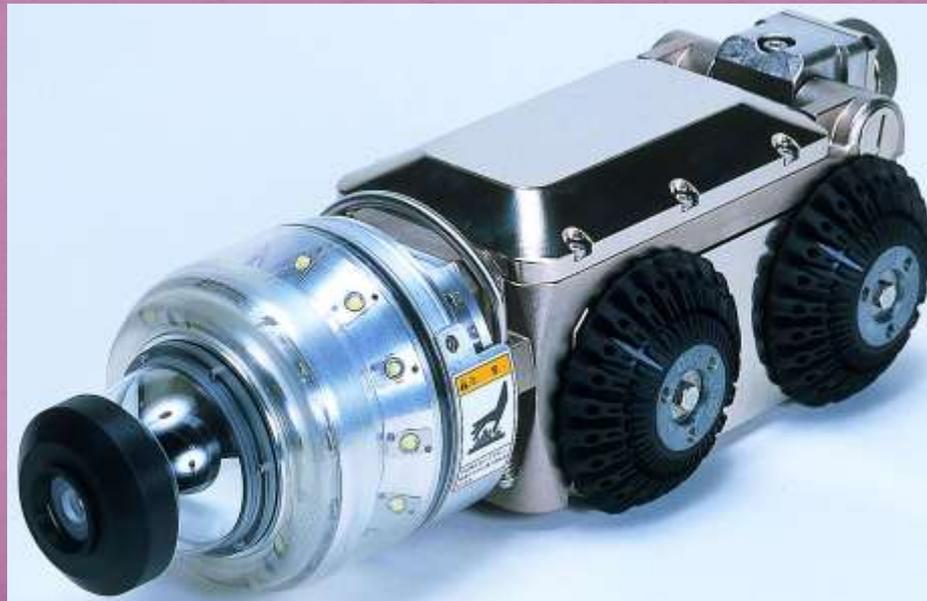
Omnidirectional video camera

Inspection by omnidirectional video camera **was partially introduced through public tender in FY2009 and has been fully practiced since FY2010** to achieve efficient operation and maintenance of conduit systems.

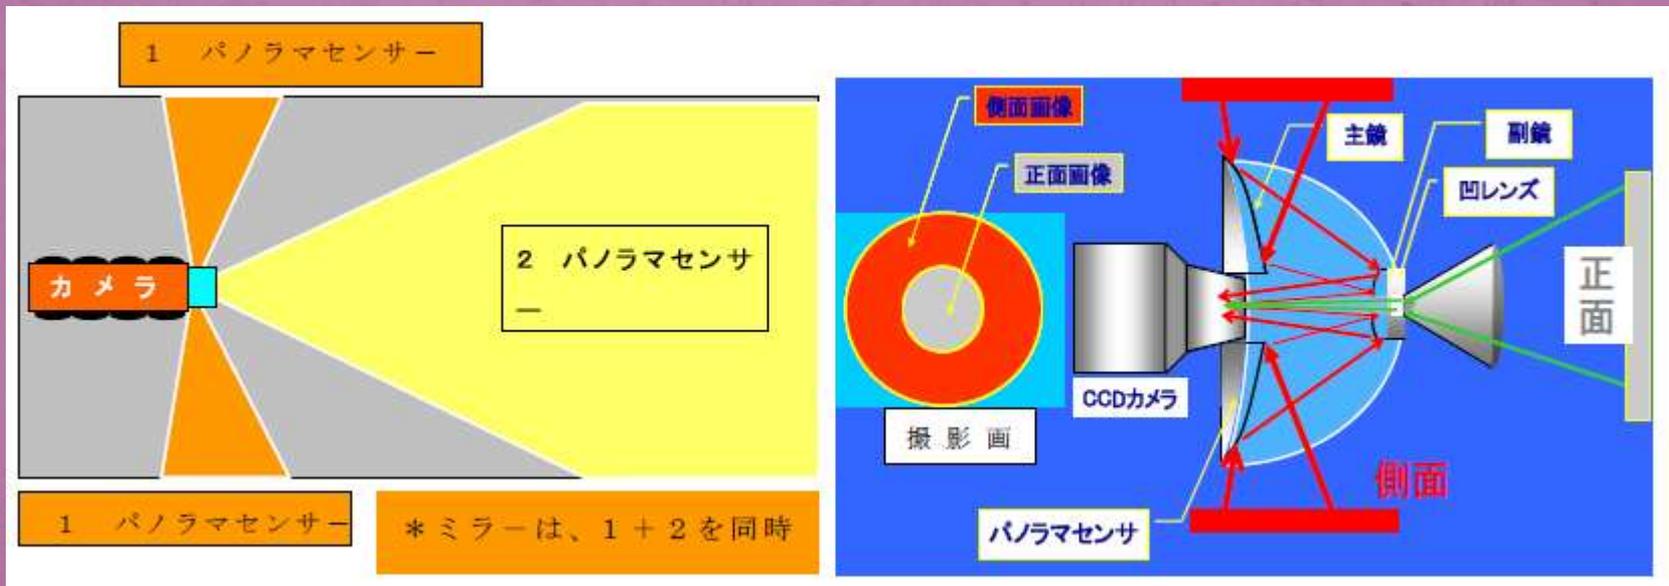
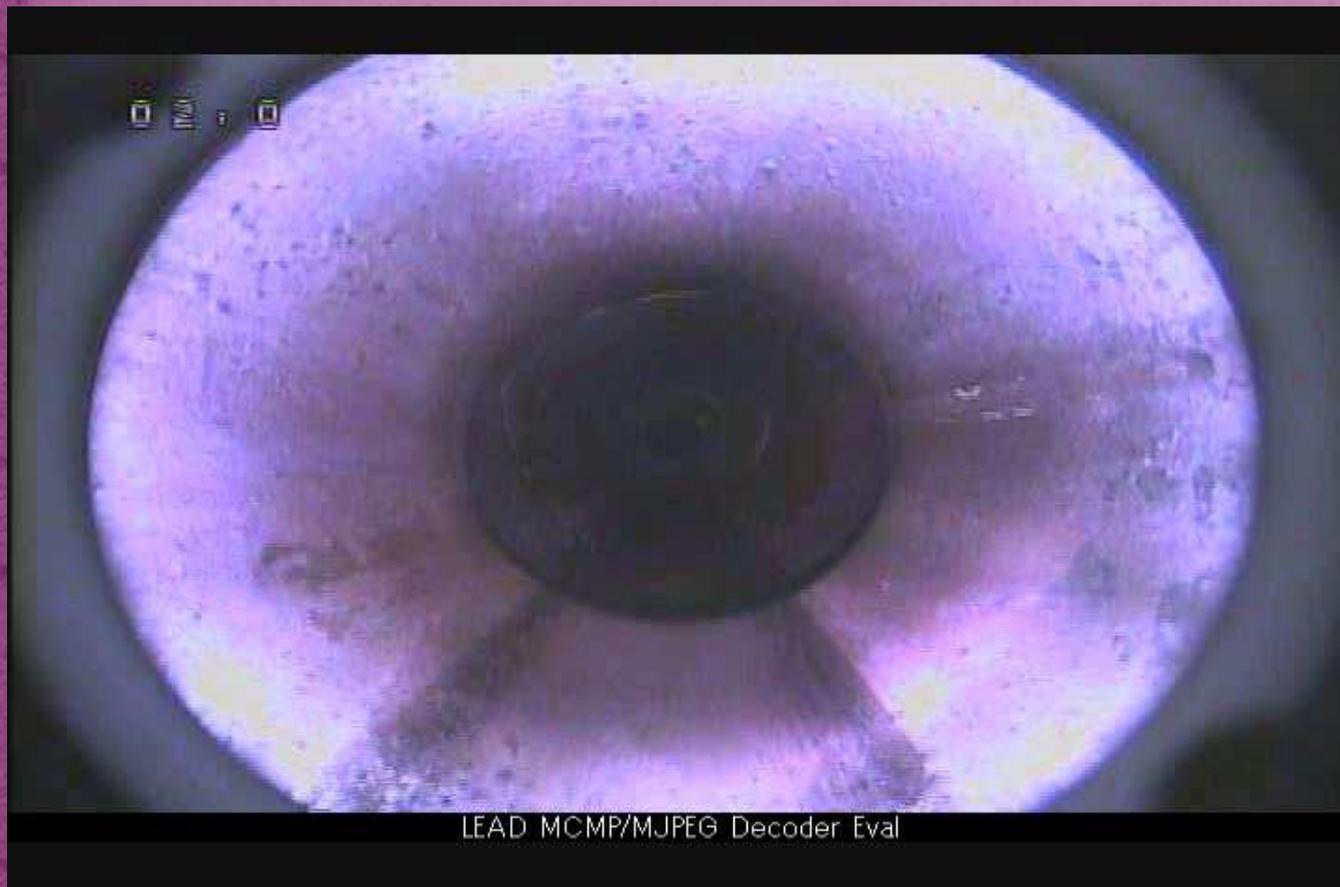
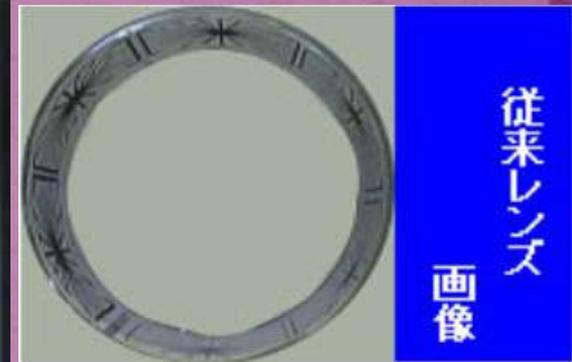
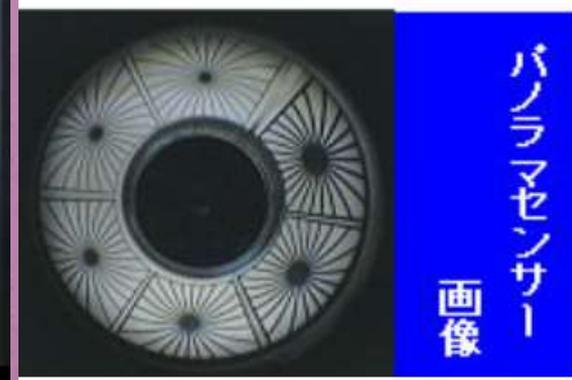
- (1) Omnidirectional video camera with panoramic sensor
- (2) Monitoring side view while moving forward, significantly decreasing the time required for video shooting

View

Schematic

Video picture (still image)

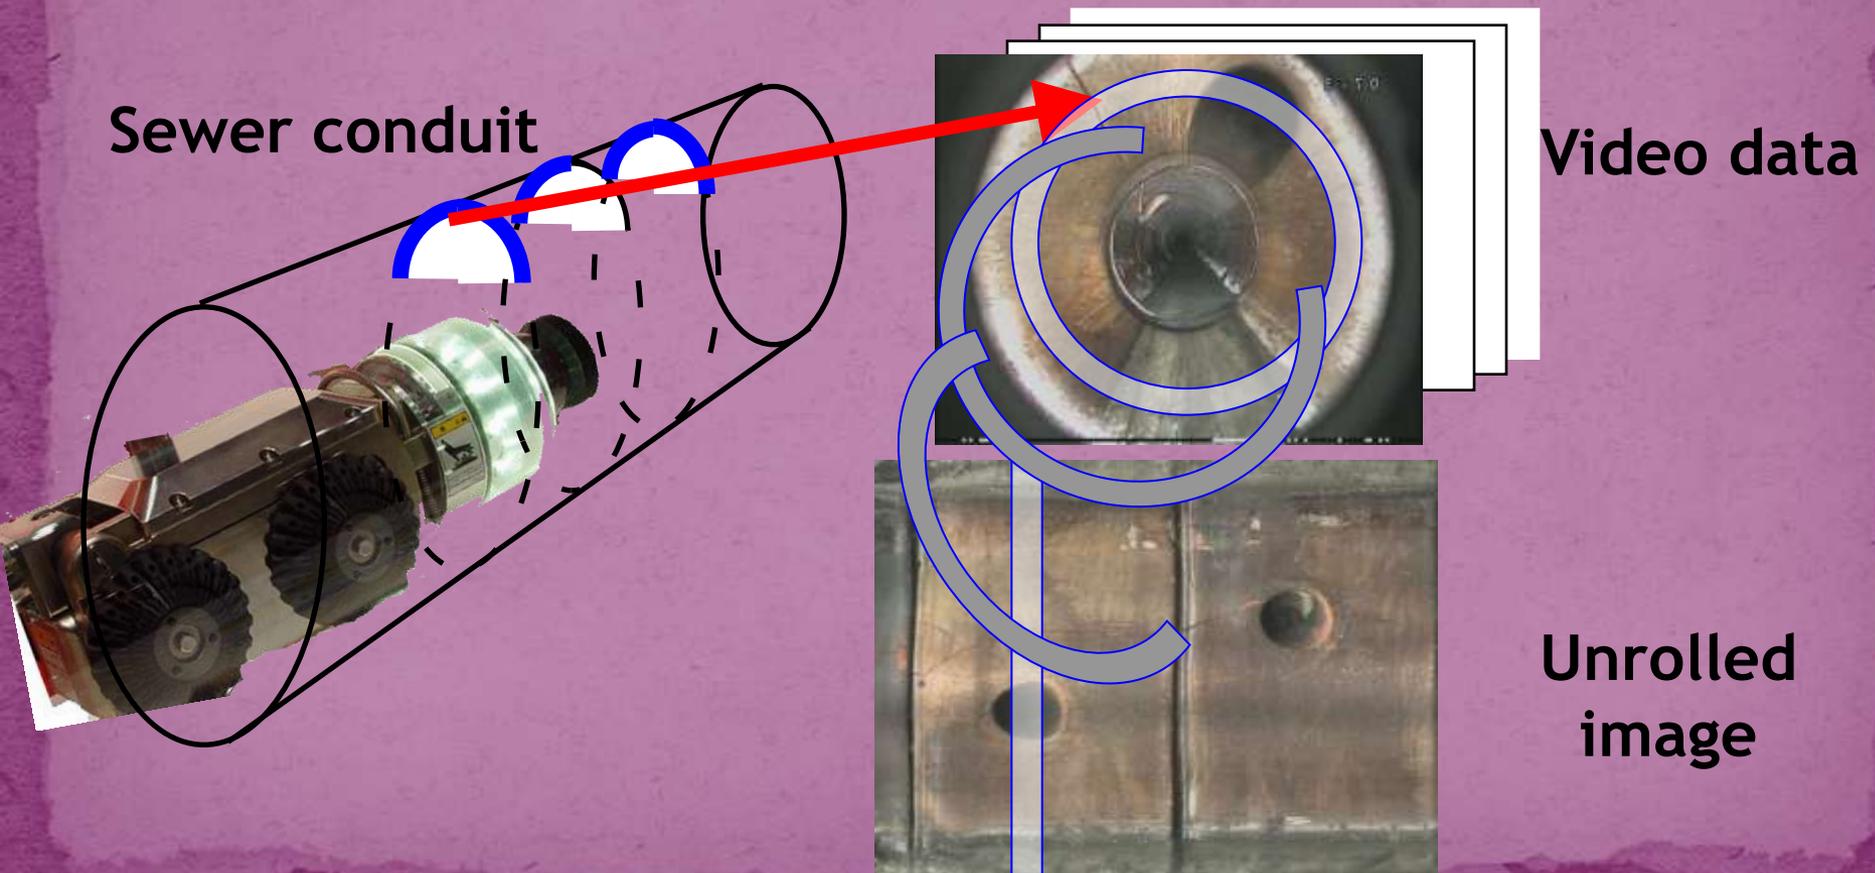
Unrolled Image of Conduit Inner Surface

Side wall data is processed by coordinate transformation to reproduce its unrolled image.

Unrolled image

Pipe bottom → A

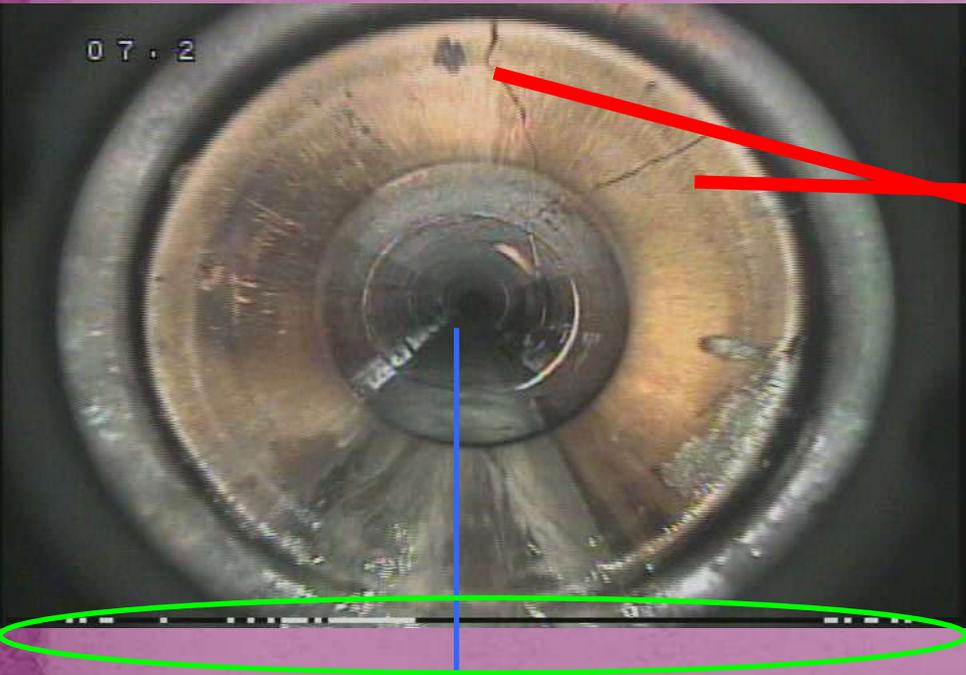
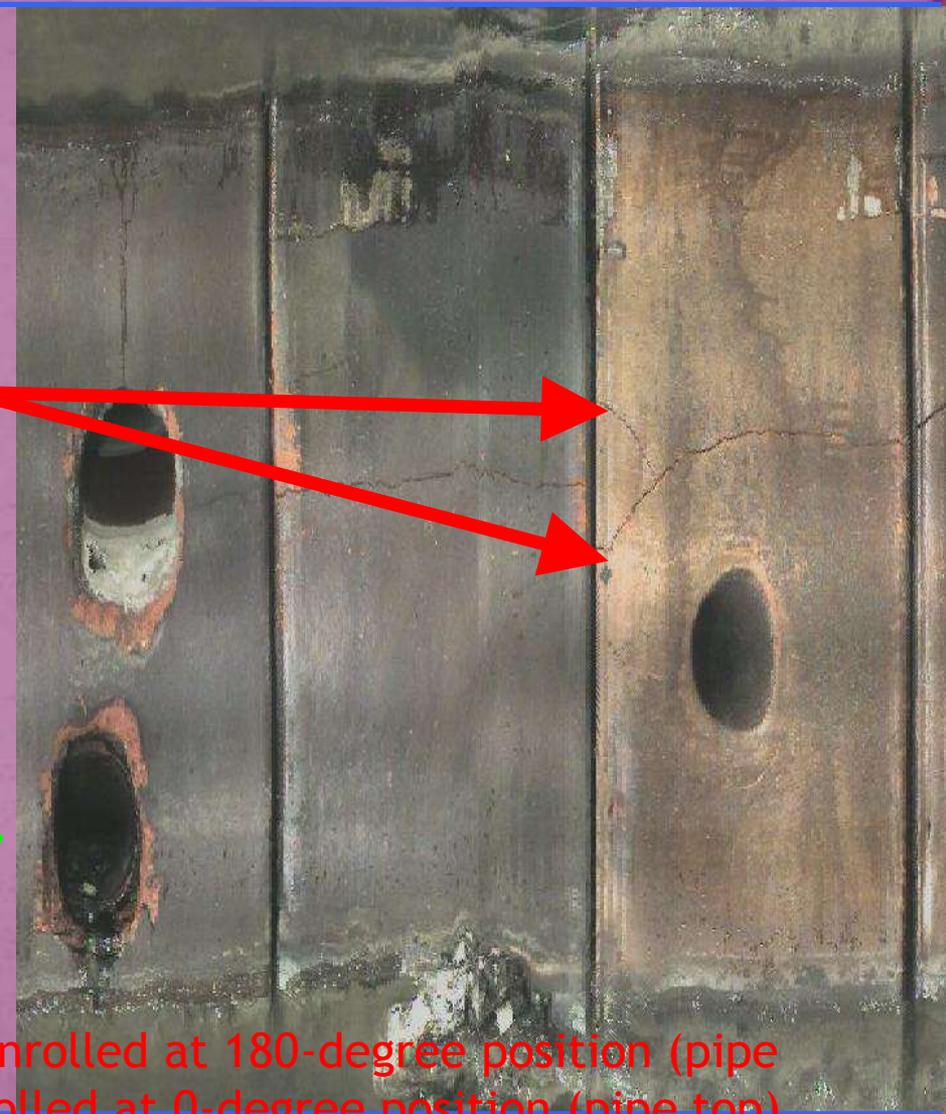
B
Original image

Unrolled image

* Picture shown above is an image unrolled at 180-degree position (pipe bottom). By default, an image is unrolled at 0-degree position (pipe top).

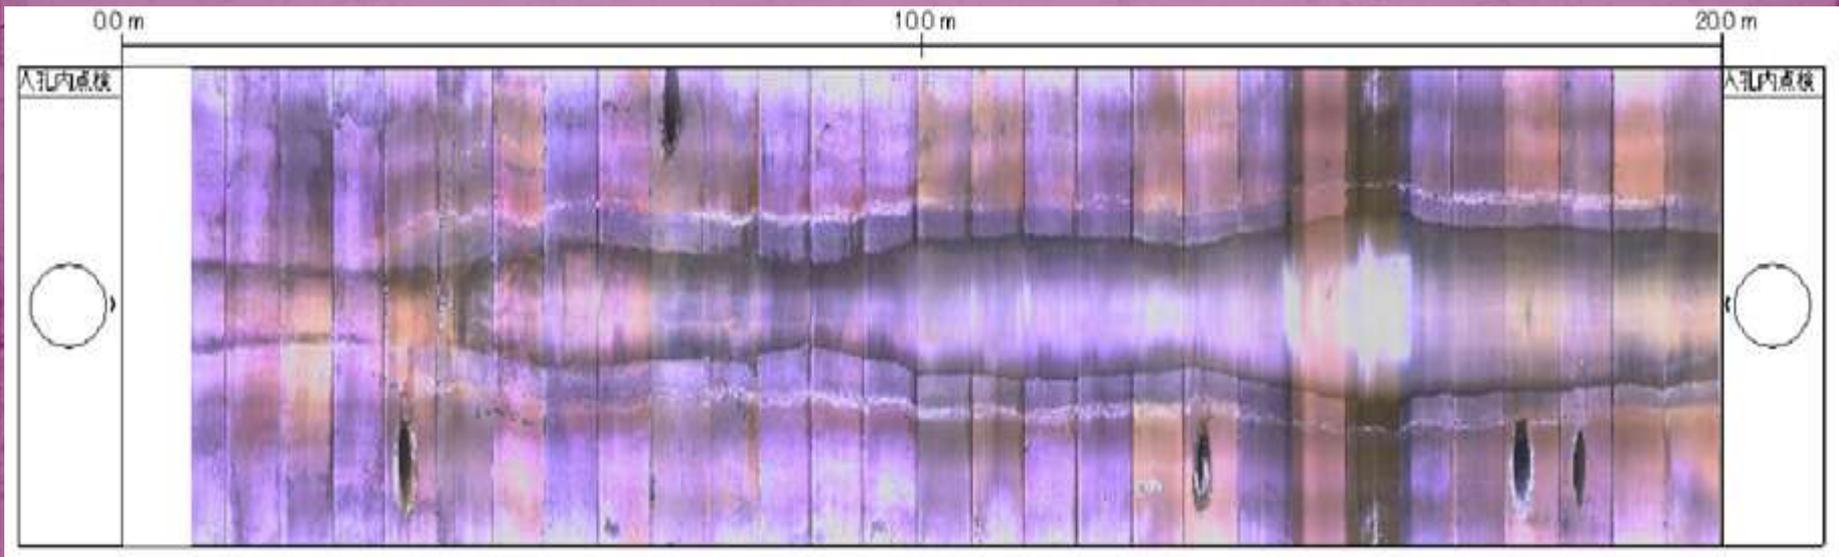
Unrolled images

Conduit Inner Surface Image Unrolling System

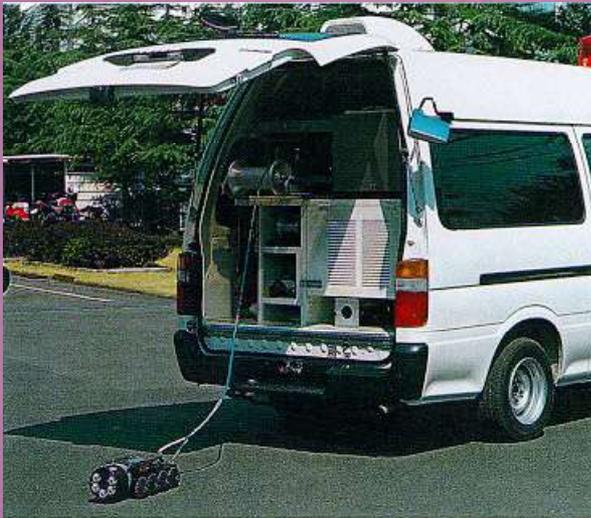
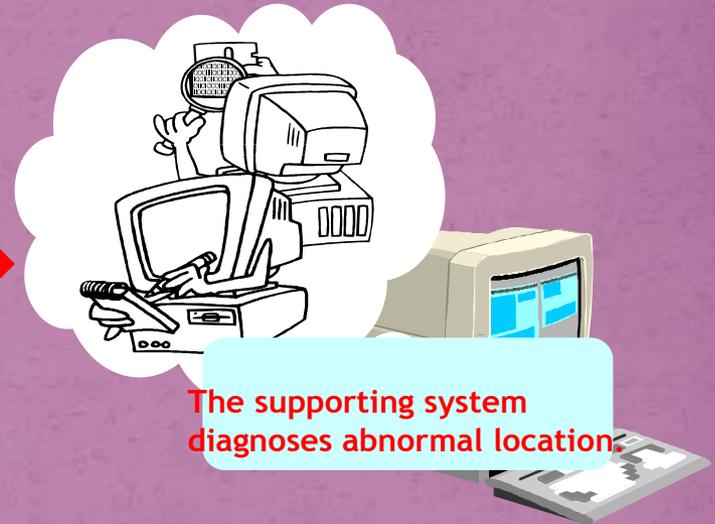
The system enables remote PC diagnosis of conduit inner surface, the job that have been done by on-site operator so far.

The supporting system diagnoses abnormal location.

* Semi-automatic diagnosis; The diagnosis needs to be confirmed by human inspector.

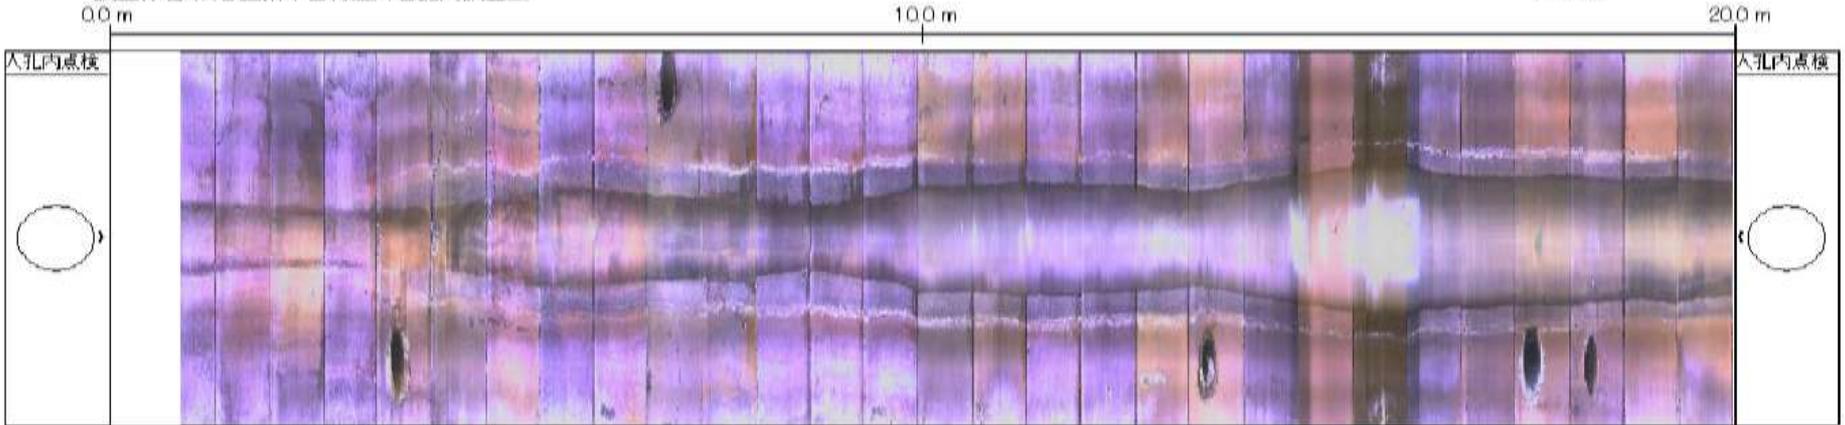
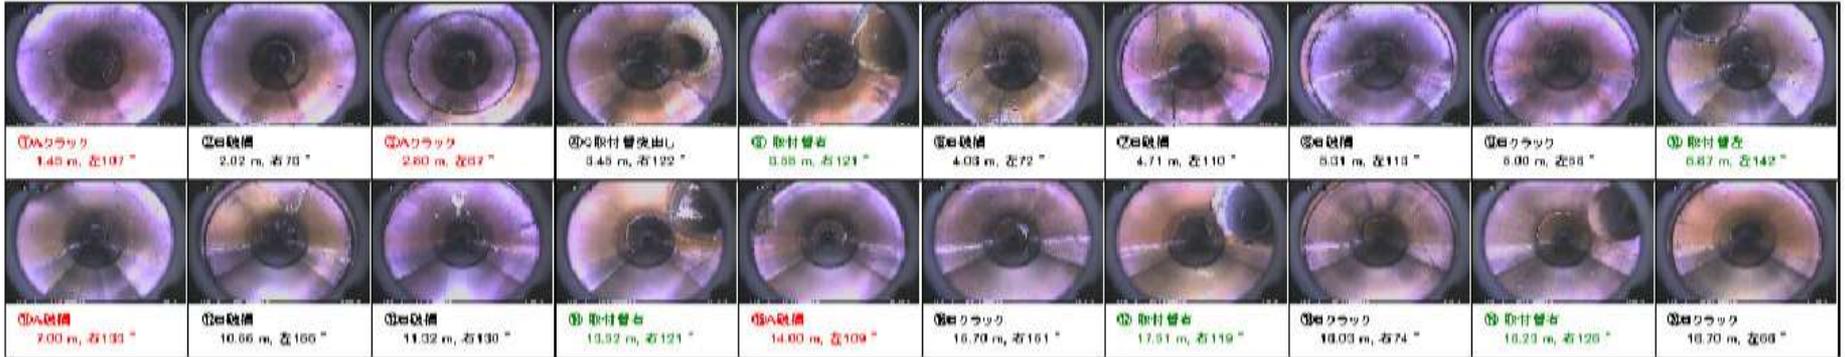
Unrolled Image Record File (Diagnosis results)

路線番号: 42 (1/2)
 調査日付: 2005年12月16日
 上方展開

調査件名: 渋谷区南平台付近外管路内調査工

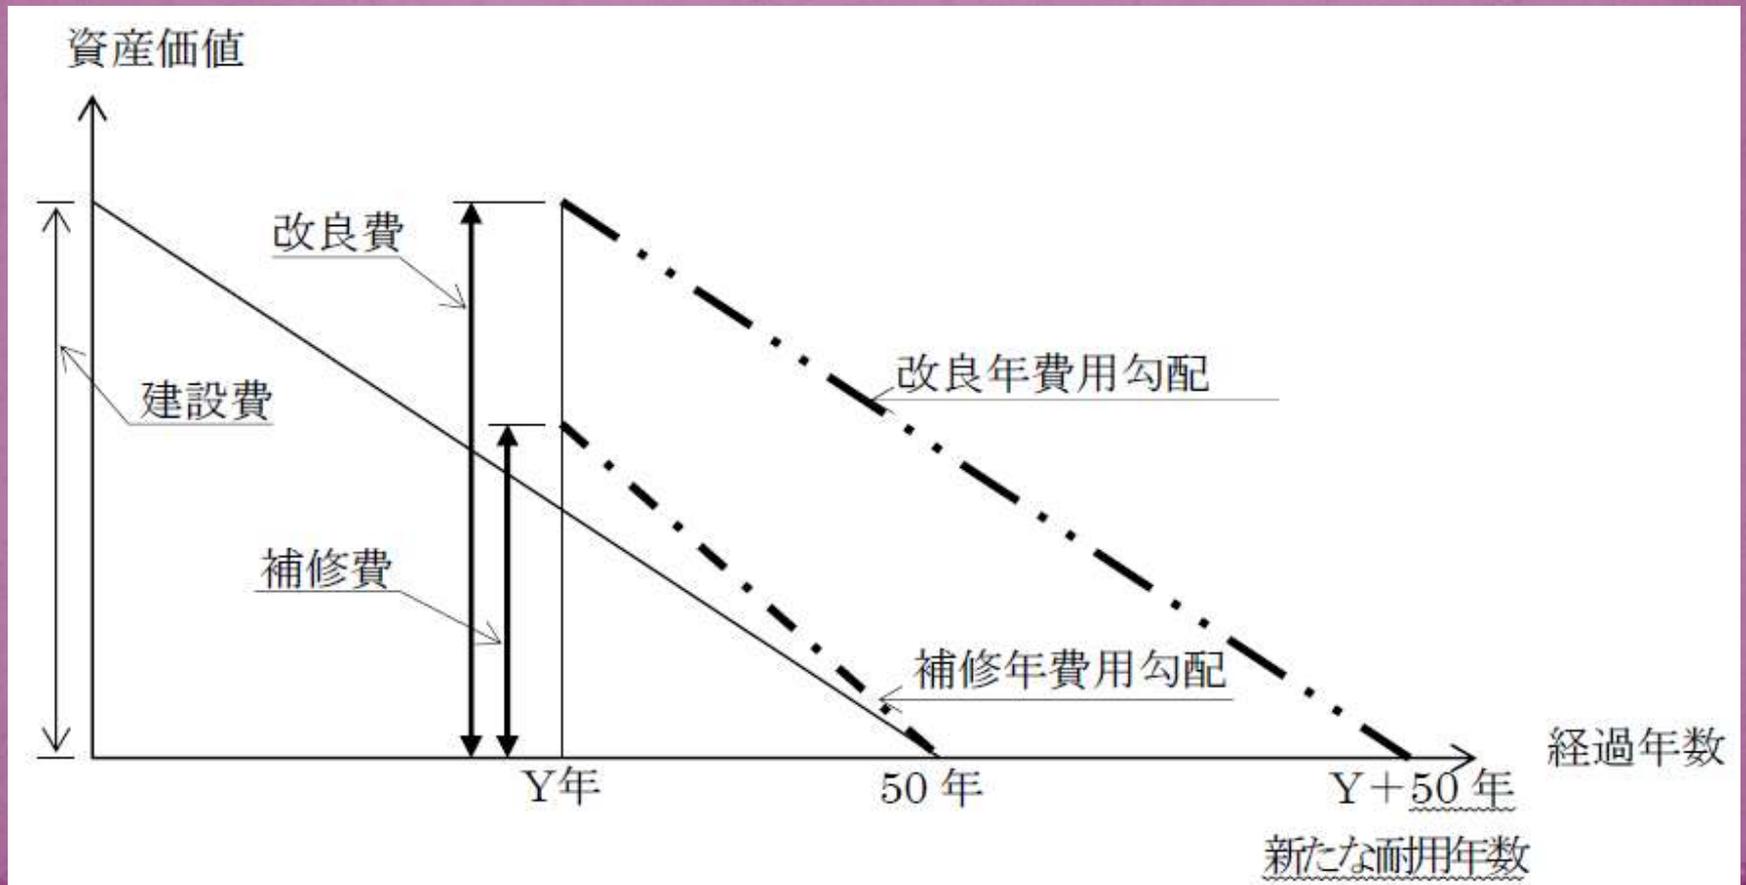
Comparison of cost and service life between repair and improvement works on the pipes needed remedy after Y years.

How to judge repair or improvement works (economical comparison).

Improvement work is planned when the following inequality is established.

$$\frac{\text{改良工事に要する費用}}{\text{新たな耐用年数}} \leq \frac{\text{補修工事に要する費用}}{\text{残存耐用年数}}$$

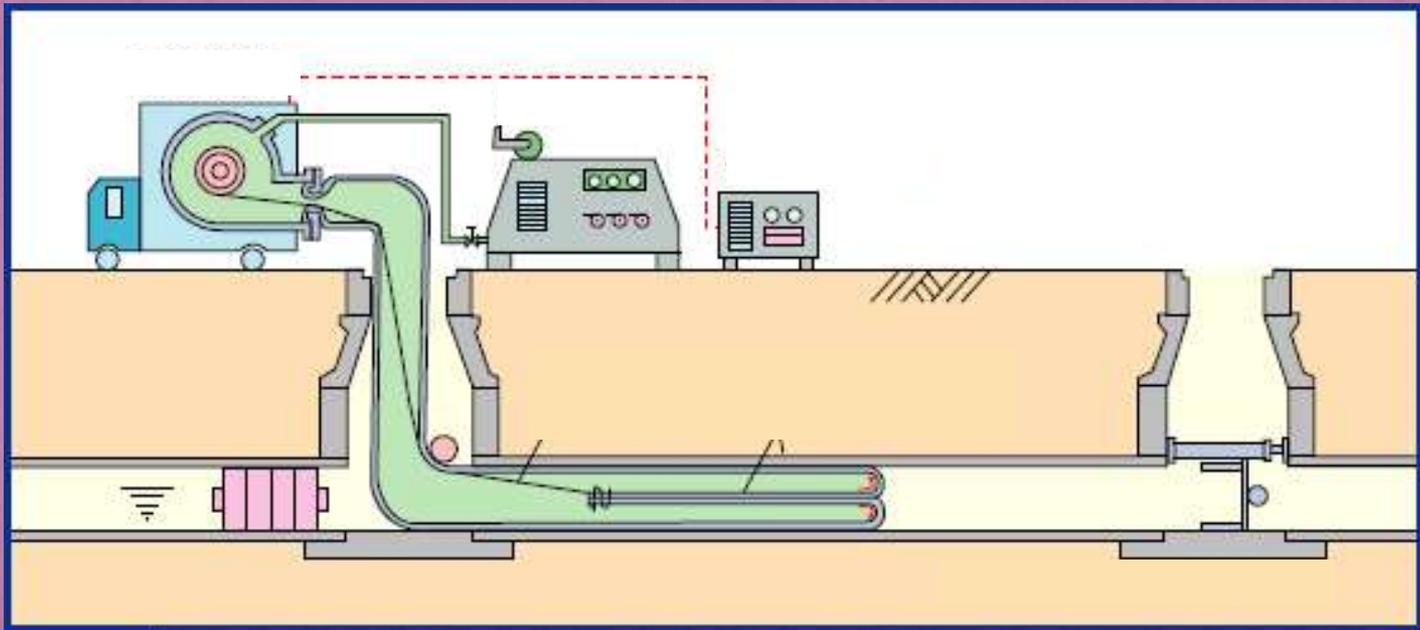
Inversely insert fibrous repairing material impregnated with hardening resin into an existing manhole. Inflate the material or expand it with water to press onto the inner surface of the existing pipe until the resin hardens.

(1) Cured-in-place pipe inversion method

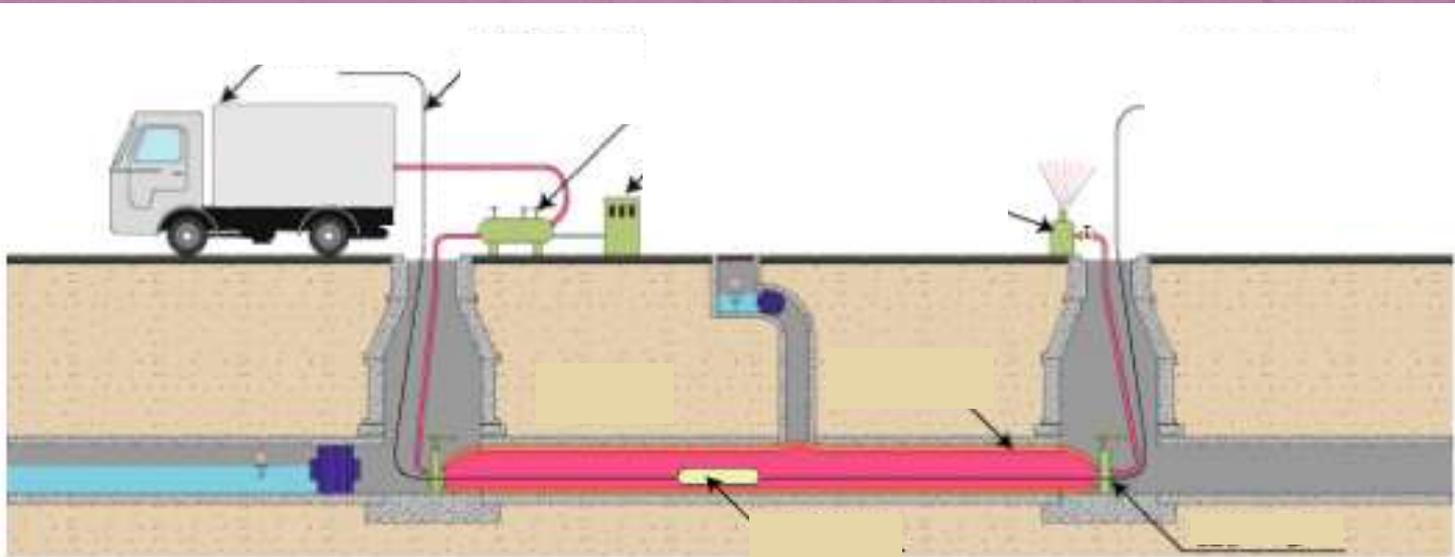
Insert and pull fibrous lining material impregnated with hardening resin into an existing pipe. Inflate the lining material to press onto the inner surface of the existing pipe until the resin hardens.

(2) Lining pipe: pull and press

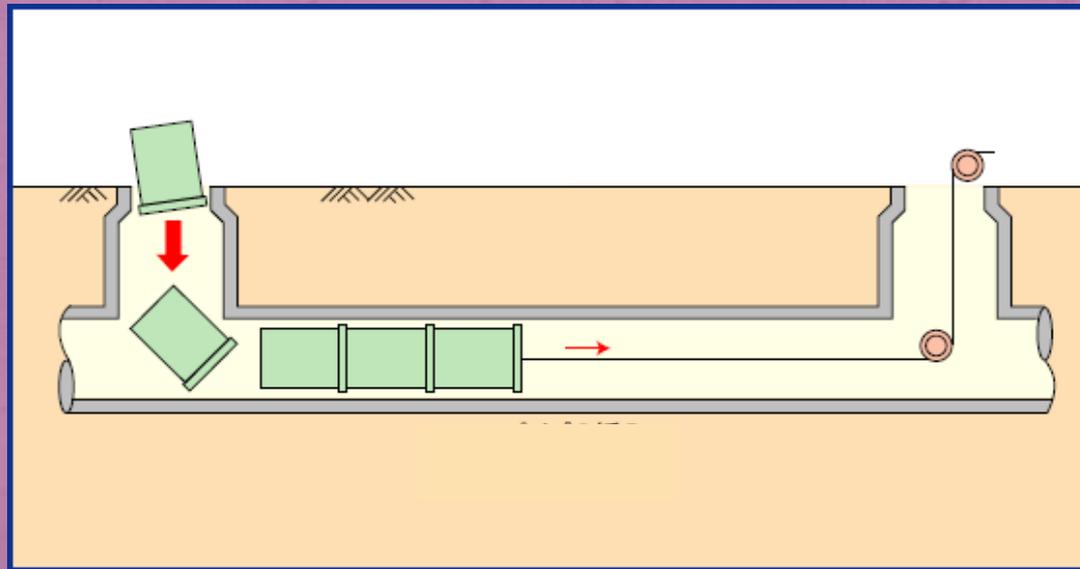
Insert and pull a series of prefabricated pipe modules smaller than the existing pipe in diameter. The gap between new and old pipes is filled to unite them as a new duplex pipe. The inner pipe modules prefabricated in factory assure reliable construction.

(Example)
FRP pipe
modules

(3) Slipling method

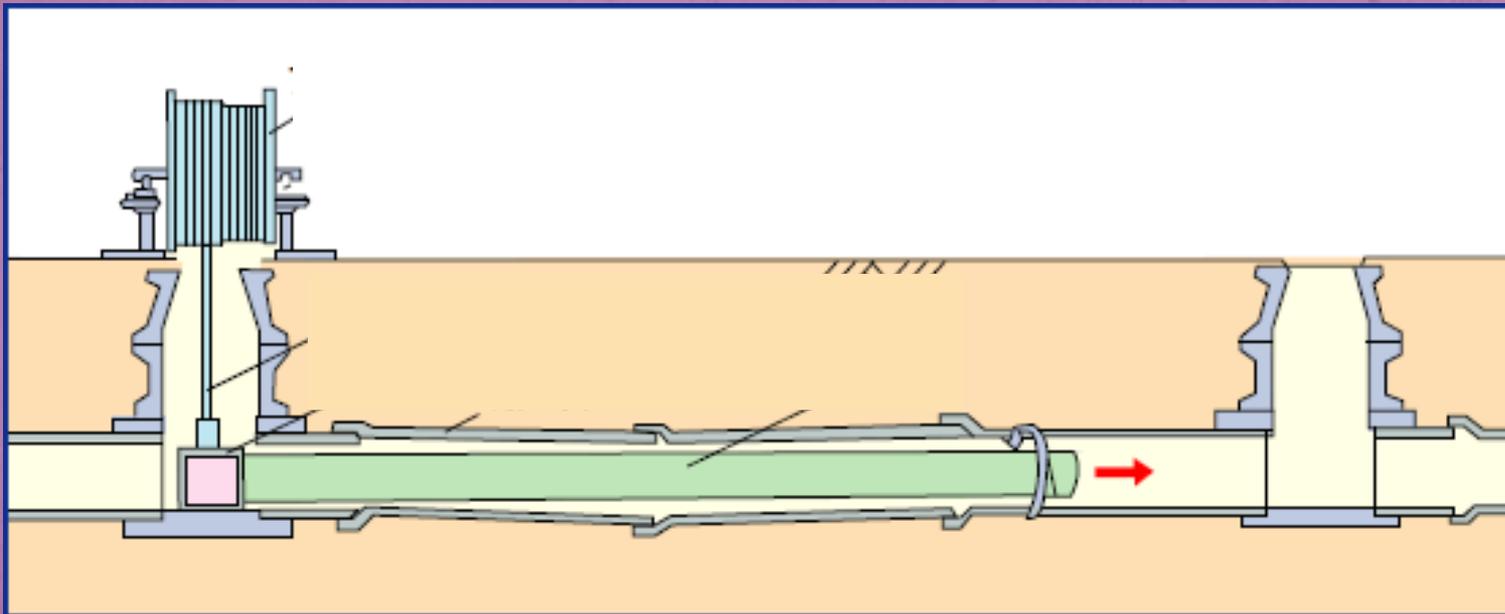
Create a new inner pipe inside an existing pipe, by inserting hard vinyl chloride material in a spiral manner. The gap between new and old pipes is filled by back-filling material to unite them as a new duplex pipe.

(4) Spiral liner method

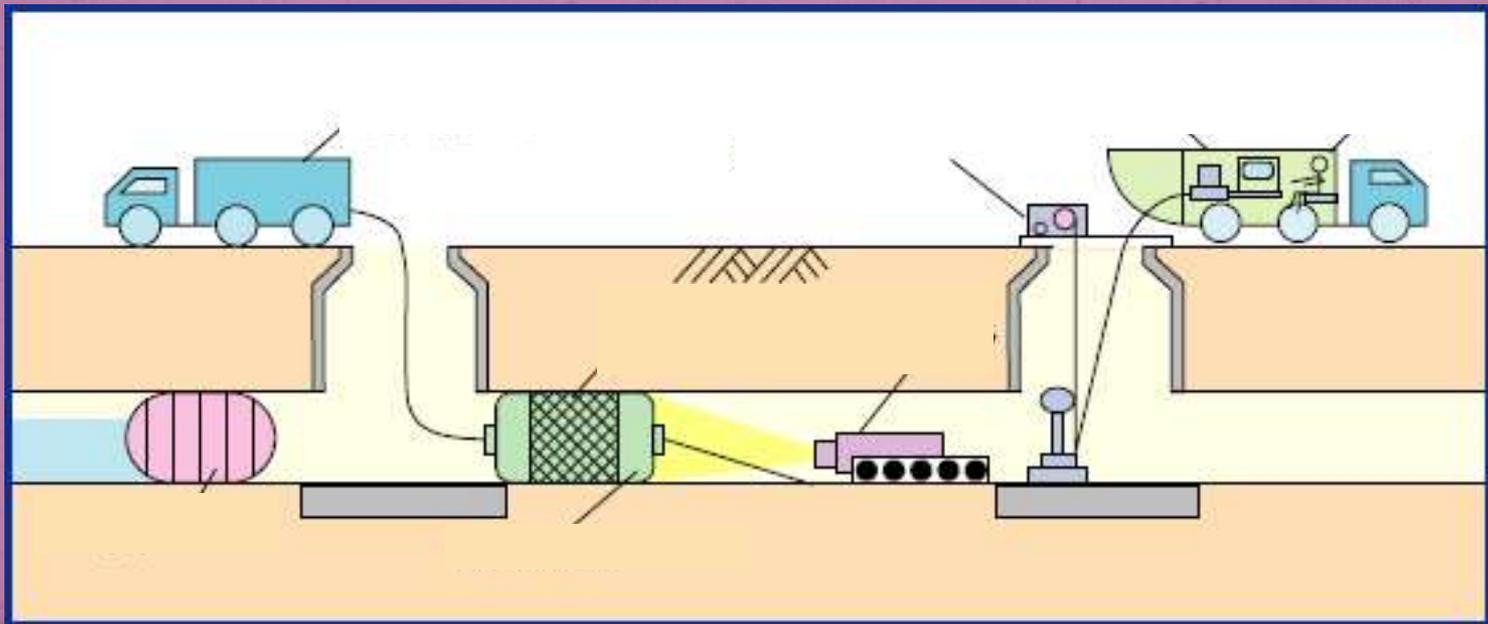
Partial repair

Apply fibrous repairing material impregnated with hardening resin onto the surface of repairing section. The resin hardens by heat, light, or time.
